Metallurgical Failure Analysis of Fasteners in an Impeller Assembly

L.R. Curtis

This paper examines a failure analysis of the bolts from a failed joint between an impeller blade and a rotating assembly unit. The bolts failed due to poor thread manufacture and installation. Sharpened thread roots led to high stress concentrations that favored crack initiation. An oddly shaped thread profile allowed friction between mismatched thread surfaces. Poor installation procedures allowed for the possibility of overtightening to nucleate cracks in the head-to-shank interface (which had a smaller radius and therefore a higher stress concentration) and possibly also in the thread roots. Each of these influences contributed to crack initiation in the bolts. After cracks had formed, bending fatigue then propagated the nucleated cracks to final fracture. The failure analysis also recommended using bolts with rolled threads, which allow a more complete fit between mating male and female threads, and assuring that an appropriate preload is placed on bolts during installation.

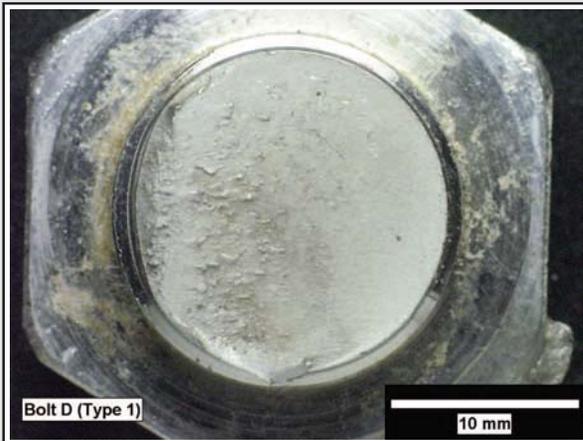
were identified on each fracture surface, which universally showed signs of bending fatigue, with mild to severe stress concentrations.^[1] Figures 1 and 2 show the fracture surfaces observed in bolts D and B, respectively. Likely points of crack initiation were identified for each bolt head, except for bolts I and J, for which the shank was used because no corresponding bolt head had been received. In some cases, scanning electron microscopy (SEM) was used to identify and/or confirm likely locations for fatigue crack initiation. Ductile fracture features (dimples) were prominent near thread roots. Fatigue striations could be observed at higher magnifications, as shown in Fig. 3.

Fig. 1 Fracture surface of bolt D (type 1 bolt)

Bending fatigue was clearly the means by which a crack propagated through the material. The fatigue crack patterns on the bolts (Fig. 1 and 2 are examples) are all consistent with bending fatigue occurring in mild-to-severe stress concentrations. This observation suggests that, once initiated, the fatigue cracks propagated under high stress levels.^[1] Fatigue is also confirmed by the striations viewed with the SEM, as seen in Fig. 3.

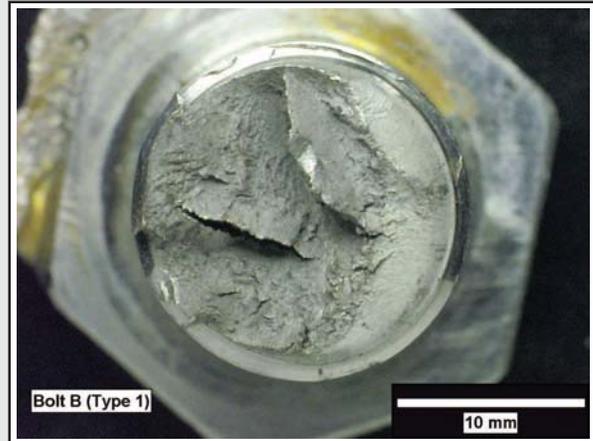
Fig. 2 Fracture surface of bolt B (type 1 bolt)

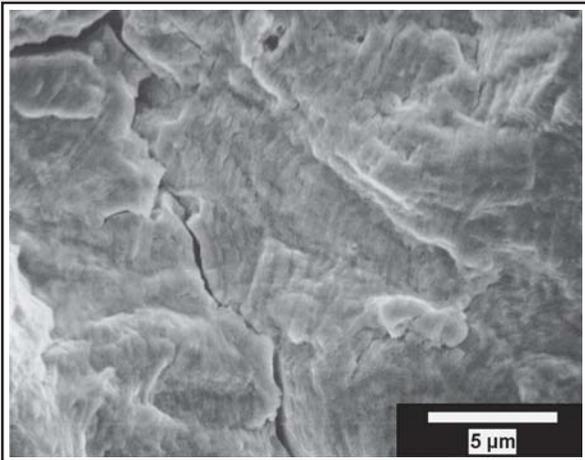
Fig. 3 SEM micrograph of fracture surface in bolt B (type 1 bolt)

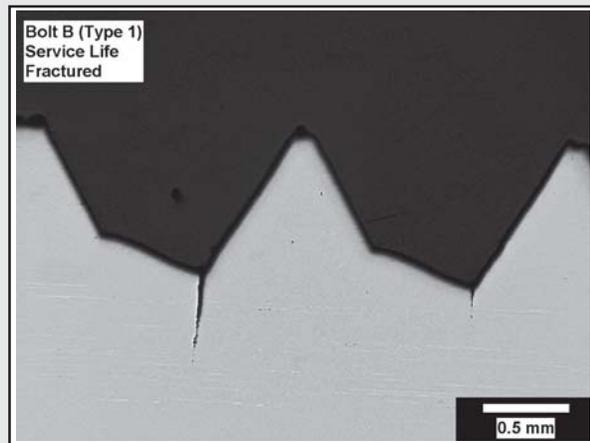
The type 1 bolt showed cracking in every thread root on the side farthest from the tack weld on the bolt head. Figure 4 shows typical cracking. Cracks were also observed on the side closest to the tack weld, but these cracks were not as pronounced or extensive. Also visible in Fig. 4 was the unusual thread form of the type 1 bolt, which featured sharpened and asymmetrical roots. In contrast, the type 2 bolt had a thread form with rounded thread roots, as seen in Fig. 5. Some thread roots in the type 1 bolt had elongated features resembling pits in the thread roots directly above the fracture area

Fig. 4 Thread profile in bolt B (type 1 bolt) showing cracks in thread roots and irregular shape of thread form

Identifying a single cause of failure, however, is more difficult. Of the two bolts observed metallographically, the type 2 bolt appeared to resist cracking better than did the type 1 bolt. The type 1 bolt had cracks in every thread root on the side opposite the tack weld. Only three crack roots were observed in the type 2 bolt. In addition, the type 2 bolt had higher crack resistance at thread roots because these areas were generously rounded, as opposed to the pointed thread roots of the type 1 bolt. The sharper thread roots created higher stress concentrations that favor crack initiation.^[4] Additionally, the type 2 bolt had a larger head-to-shank radius, which lessened the stress concentration experienced just below the head, and the type 2 bolt head was formed by upsetting, which provided a favorable grain flow^[3] and hence further resistance to cracking by overload or fatigue. Finally, the type 2 bolt had a more traditional thread shape; it appears likely that the thread shape of the type 1

- Bolts with a rolled thread should be used. The rolling action will impart a layer of compressive residual stress, which will provide resistance to fatigue crack initiation and fretting.
- The thread shape should provide a proper fit between male and female threads (to reduce the possibility of fretting), and thread roots should be rounded (to eliminate stress concentration points that can lead to crack initiation).
- An appropriate preload should be placed on each bolt. The absence of any control in this area can lead to fatigue crack nucleation as well as fretting; it also introduces the possibility of overtightening.

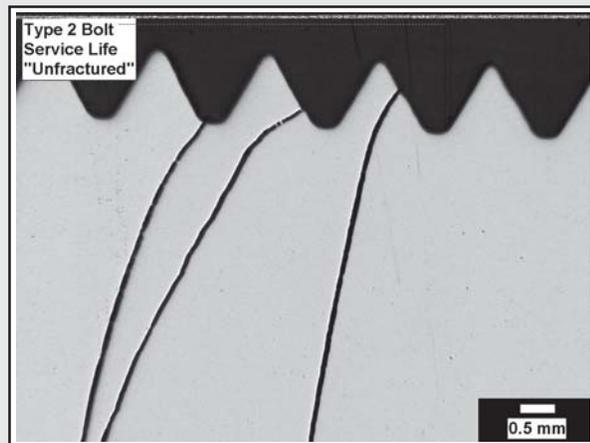
Fig. 5 Thread form profile in type 2 bolt. The three cracks seen here were the only ones in the bolt and extend almost across the entire diameter.

The type 2 bolt showed cracking that initiated at or near thread roots in three locations. One of the three nucleated cracks joined with an adjacent crack; thus, only two crack ends were visible. One of the crack ends appeared pointed, similar to that of a fatigue crack; the other crack end appeared blunted and rounded, similar to that of a corrosion-assisted crack. Each of the cracks extended across almost the entire diameter of the bolt and initiated in thread roots toward the side of the bolt with the tack weld.
